## Mandatory Action Jan. 2017

Inspection of the Horizontal Stabilizer tail attachment brackets

Transportation Safety Board of Canada - **AVIATION SAFETY ADVISORY A16O0137-D1-A1  
Zenair Zodiac CH-601A—Risk of structural failure of the horizontal stabilizer**

**Subject: AVIATION SAFETY ADVISORY A16O0137-D1-A1**  
**Zenair Zodiac CH-601A – Risk of structural failure of the horizontal stabilizer**

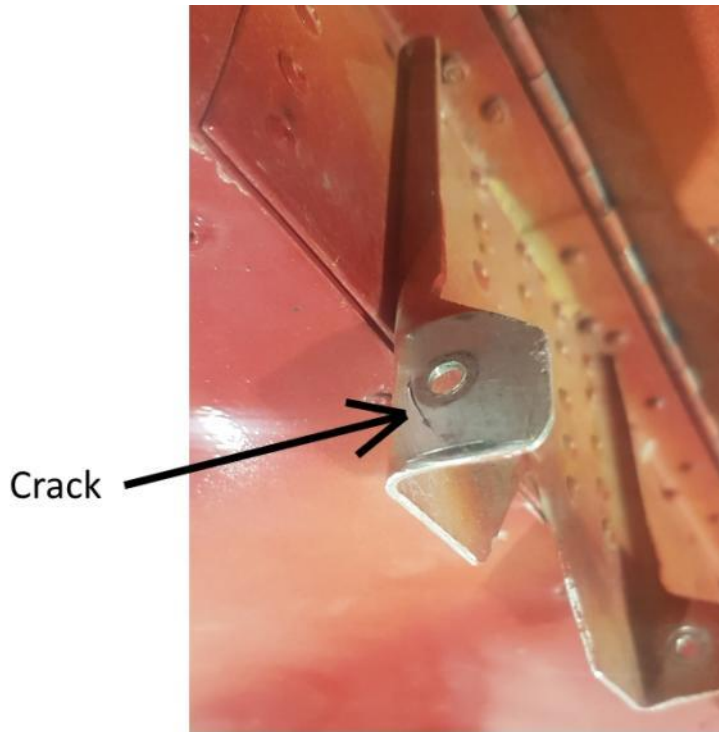
Crack

View of H.S. rear attachment bracket. A crack is developing in the part. Part must be replaced.

Replace parts that do not match the aircraft airframe blueprints (drawings). Replace parts that have been drilled or assembled incorrectly. The H.S. must fit snug to the fuselage fittings. Bolts when tight must not bend the H.S. fittings. Correct type rivets must be installed properly as per the design standards manual. If you did not assemble your airframe, hire a certified aircraft mechanic to complete this task. Log book entry must be made. When reinstalling, use new AN bolts and self locking bolts. Torque them as per AC 43-13 1B and 2B. Do not over tighten the bolts. Once installed, check control cable tensions, all connections, interferences, etc. See [http://www.newplane.com/Service Letters Bulletines/Control%20cable%20tensions%20Zodiac.pdf](http://www.newplane.com/Service_Letters_Bulletines/Control%20cable%20tensions%20Zodiac.pdf)

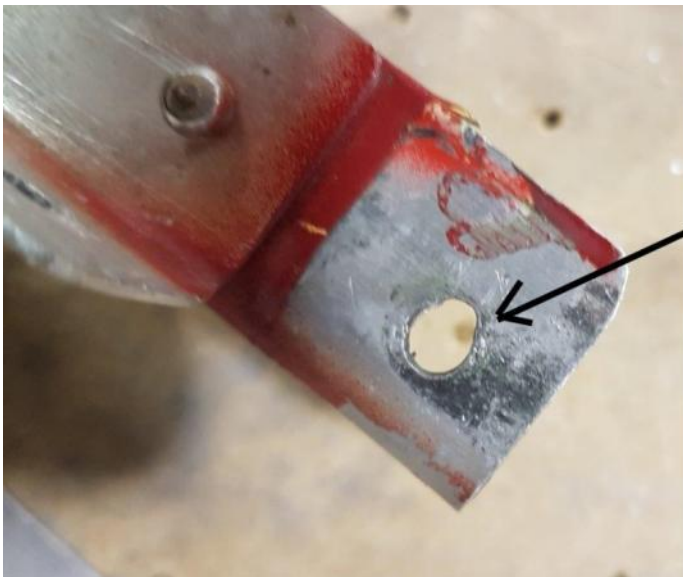
Strange hole.  
Part must be changed.

View of H.S. front attachment bracket. Bolt hole was not properly drilled. Part must be replaced.

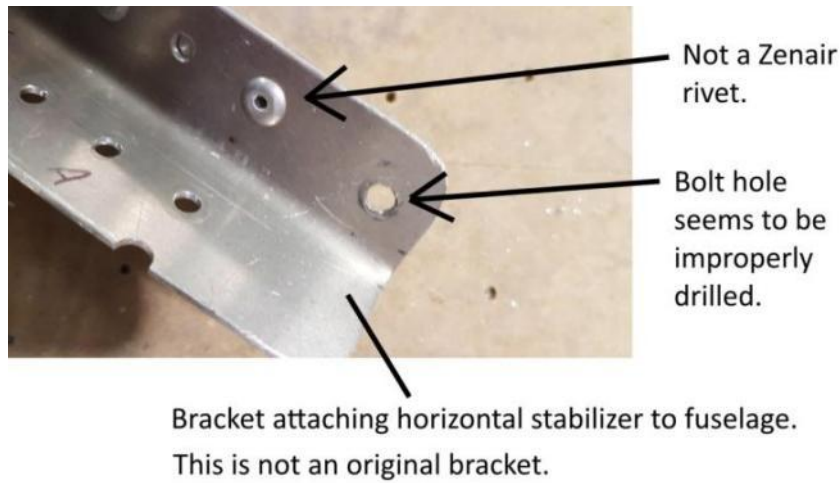
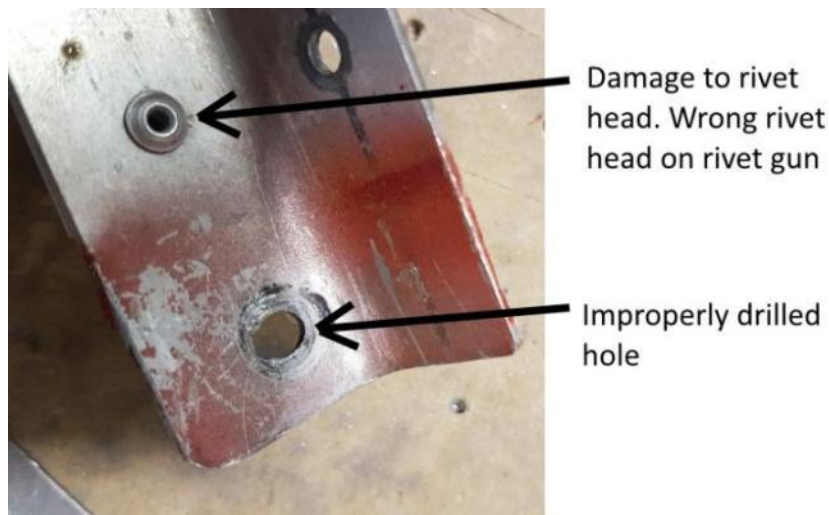
Above parts must be replaced.
