## Mandatory Action Jan. 2017

Inspection of the Horizontal Stabilizer tail attachment brackets

Transportation Safety Board of Canada - **AVIATION SAFETY ADVISORY A16O0137-D1-A1  
Zenair Zodiac CH-601A—Risk of structural failure of the horizontal stabilizer**

**Subject: AVIATION SAFETY ADVISORY A16O0137-D1-A1**  
**Zenair Zodiac CH-601A – Risk of structural failure of the horizontal stabilizer**

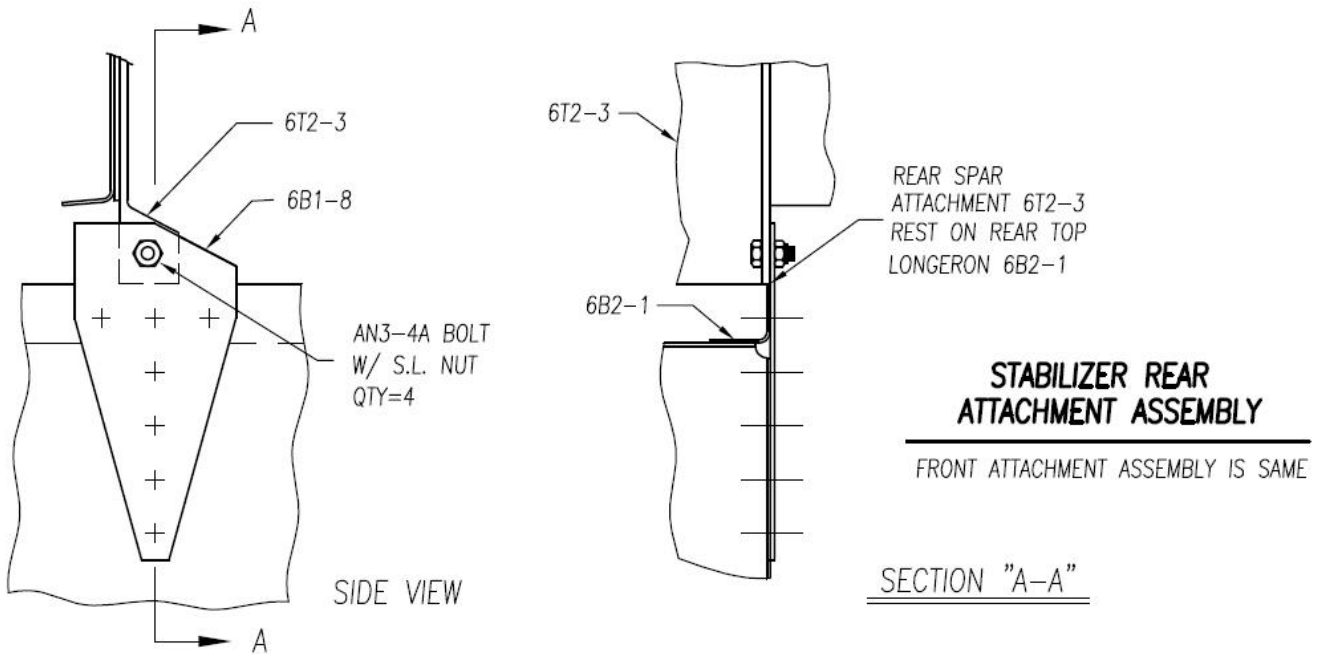
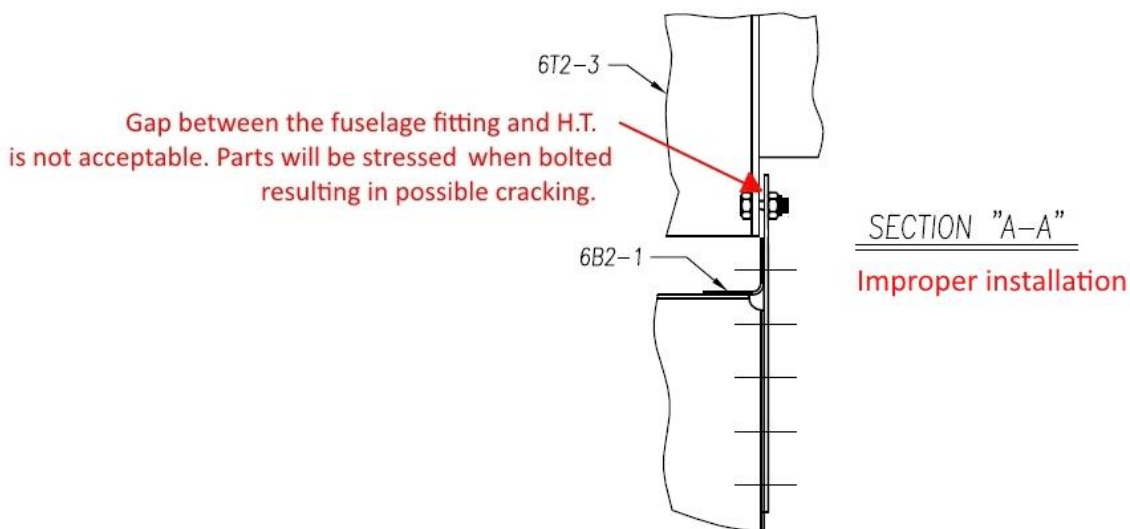
Above assembly drawing is for a typical CH 601 aircraft. Each CH design is different. Use your airframe model blueprints (drawings) and not the above example for inspection and installation.
